World Journal of Engineering

Experimental investigation of bearing wear of a gear unit DMGH 25.4 of horizontal cement mill

Purpose – Rotating machines play a strategic role in the process; it is the case of a gear unit of a cement mill. These machines are composed of tribo-pairs (bearings and gears, etc.) subjected to mechanical stress and harsh industrial environments. This study aims to make an experimental investigation of bearing wear of a gear unit DMGH 25.4 of a horizontal cement mill.

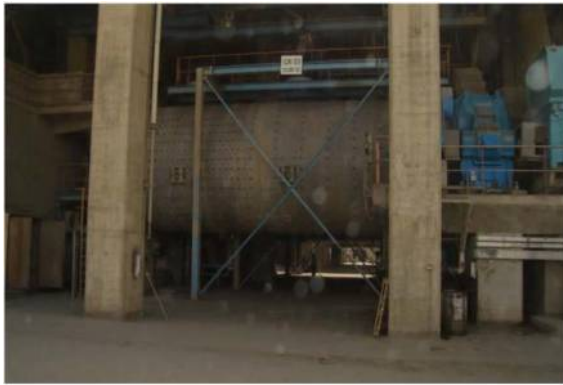
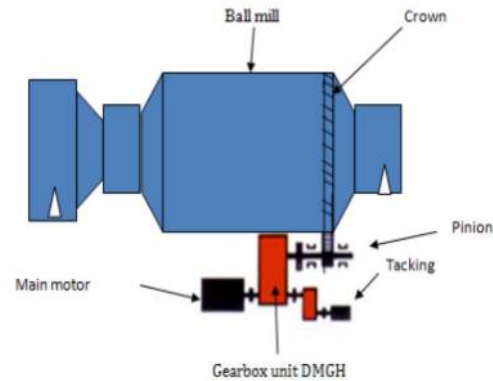
Figure 1 Description of cement mill DMGH25.4

The cement mill flender DMGH of the Algerian cement company ACC is a horizontal ball mill, driven by a lateral crown, as shown in Figure 1. It receives the clinker, gypsum and possibly additional materials; loading is performed by a bucket chain to the input of the machine. This mixture is generally pre-crushed with captured material and repressed by the separator using steel balls placed inside the rotating grinder; then the whole is supported by an endless screw, an elevator or another transport device to be processed downstream (Manual, 1999). It consists of a main motor (direct current motor ANGA 315); tacking; gear unit horizontal; two couplings (RWS 800 and gear coupling); and a grinder DMGH.

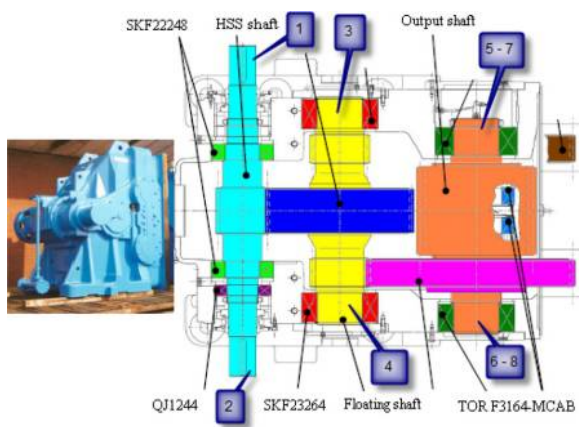
**Figure 2** Diagram of the gear unit flender DMGH 25.4

Figure 2 shows the gear unit Flender DMGH25.4, which is driven by a main motor through elastic coupling RUPLEX RLS 800. To move the grinder on a desired position, the gear unit is connected to a tacking with a motor (auxiliary motor) and a brake capable of blocking the grinder on any position. The kinematic characteristics of the gear unit are as follows (Manual, 1999):

- The high-speed shaft (HSS) frequency is 16.57 Hz.
- The intermediate shaft frequency is 7.27 Hz.
- The output shaft frequency is 2.05 Hz.
- G9H grinder frequency is 0.256 Hz.

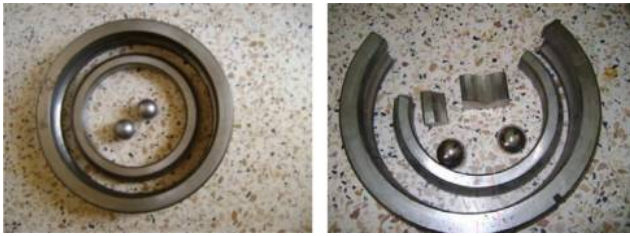
Figure 3 Image of bearing elements QJ1244 N2MA

The specimens have been taken from the outer race, inner race, half of the ball of QJ1244 N2MA and a sample of the HSS for analysis of bearing materials (Figure 3). The Chemical analysis of different samples has been done in the spectrometry central laboratory of Arcelor Metal (Annaba) via an optical emission analyzer ARL 3460.

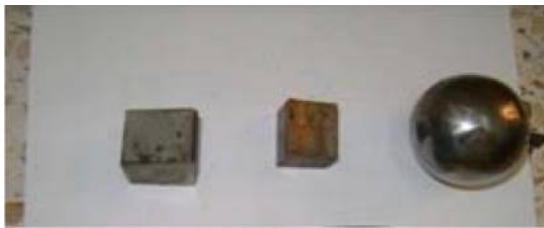
**Figure 4** Sample of macroscopic observation

The specimens are mounted under compression using an epoxy resin. Then, the mounted specimens undergo polishing. The test specimens have been taken from the bearing (Figure 4). The microhardness tests have been carried out on a Vickers indenter (Microdurometer Tukon 2500 Wilson Hardness). The applied load $P = 10 \text{ g}$, and the holding time = 15 s.

The samples (Figure 4) are observed as received, without any preparation, except cleaning with pure ethanol. These early observations (in its raw state) after wear allow going back to the real conditions of contact between the elements. The observations were made using an optical microscope Zeiss Axio Green 40 MOT assisted by computer.

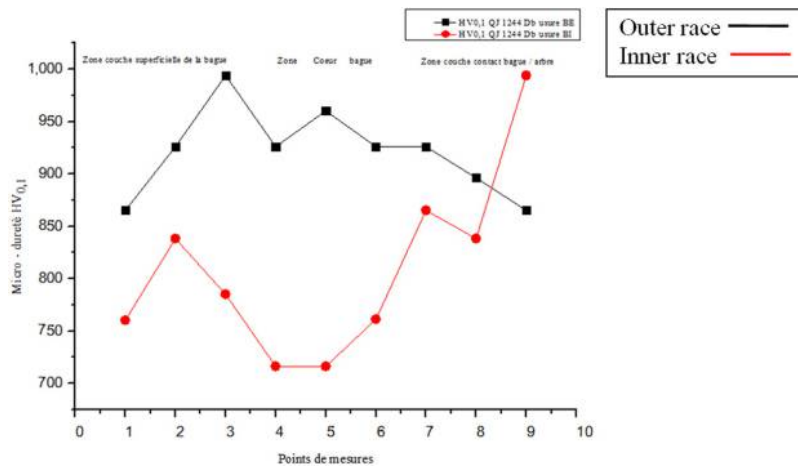
The results of the microhardness test show that the Vickers hardness of 100Cr6 steel just below the surface of the beginning wear and worn bearing QJ1244, was measured at a much higher value compared to the normal state, it's found that the hardness varies between 720 and 800 HV. The unusual hardening observed suggests that the damage was caused by the dissipation of a large surge of frictional energy lasting several milliseconds (Sigrid and Woydet, 2005). Instead of a surface with pitting or cracks raceway, typical consequences of an overload, the material in the raceway seemed to have been plated or rolled onto the surface.

Figure 6 Evolution of the microhardness of the bearing QJ1244 at beginning of wear

The micro superficial hardness of the ball is 838 $\text{HV}_{0.1}$. Figures 6 and 7 show the evolution of the microhardness of the elements QJ1244 early wear and worn bearings QJ1244 (spalling), respectively.

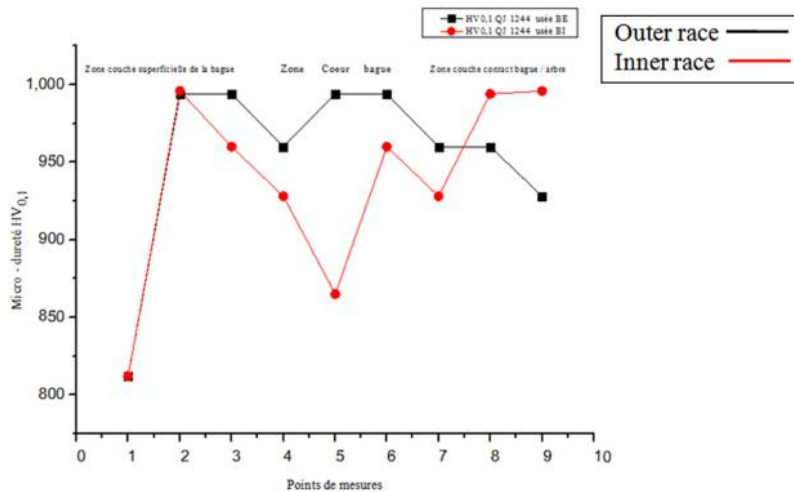
It has been noticed that the microhardness of the worn bearing is very high relative to the beginning wear bearing, which is due to the quantity of carbides formed.

Figure 7 Evolution of the microhardness of the worn bearing QJ1244 (spalling)

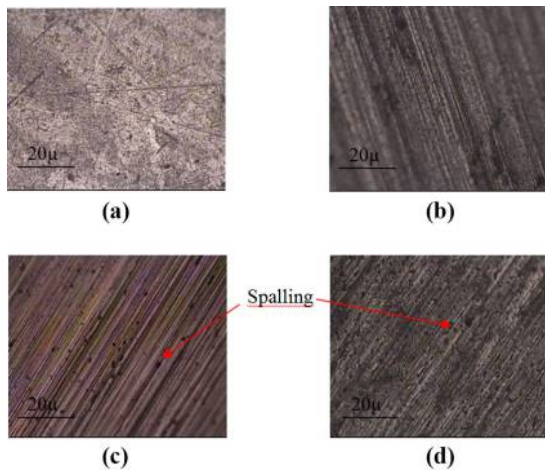
The macrostructure of a portion of the ball has non-parallel grooves and streaks (grid) because of the friction of the ball on the two rings. The bearing QJ1244 beginning wears has a strip macrostructure.

From the obtained results, it's shown that the faces are damaged and are in the form of parallel stripes in the direction of the bearings rotation. This damage is due to the abrasion resulting from the external loads applied on the bearing rings. The spalling are of a small size.

**Figure 8** Macrostructure of the bearing QJ1244 at beginning of wear (a) of the ball, (b) of the outer raceway, (c) of inner raceway and (d) of the inner race/shaft

The following figures present the images of macrographic observations of different elements in contact bearings (Figures 8 and 9).

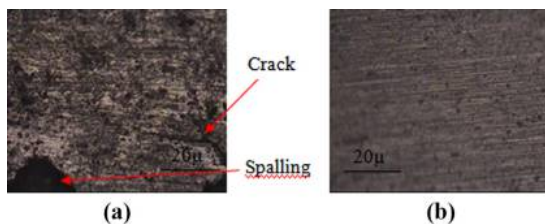
The second mode is the wear by a third body of wear debris in suspension in oil for example. These are the harsh wear particles which machined materials in contact. The macrographic observation is a part of the inner raceway of the

**Figure 9** Macrostructure of the worn bearing QJ1244 (spalling) (a) of inner raceway and (b) of the outer raceway

worn bearing QJ1244 (spalling) and shows a damaged area containing very deep scratches and spalling holders of different sizes. Spalling results from the propagation of cracks through the thickness of the material generally give rise to cracks in sub-layer depth hertz. It depends on the shear stress at the surface and the thickness of the oil film.

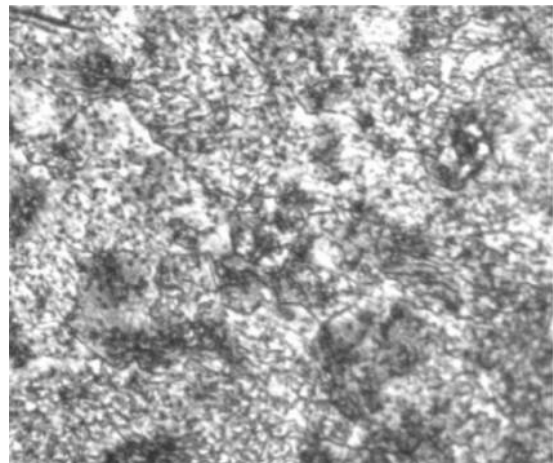
Figure 10 Microstructure of HSS

Figures 10-12 present the micro-structures of HSS and bearings, respectively.

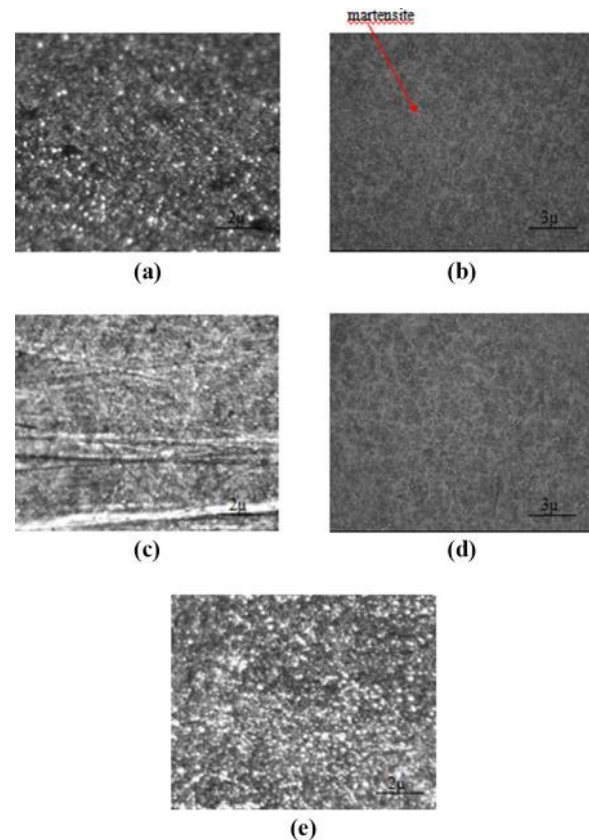
In the figures, we can see that the bearings' microstructure contains finely acicular martensite with an even distribution of high-density fine carbides. The presence of the carbides in the microstructure (heterogeneous) of 100Cr6 tends to decelerate the movement of dislocations during plastic deformation. To overcome these dislocations, the stress must be high.

Figure 12 Superficial microstructure and at the heart of the worn bearing QJ1244 (spalling)

Notes: (a) Superficial microstructure of outer raceway; (b) microstructure in heart of the outer race; (c) superficial microstructure of inner raceway; (d) microstructure in heart of the inner race; (e) superficial microstructure Inner race/shaft

The heating due to insufficient lubrication of the bearing has led to the formation of high-density fine carbides in the microstructure (heterogeneous) of 100Cr6, which tends to decelerate the movement of dislocations during plastic deformation.
